**INFORMATION ON THE EXPLOITATION OF MINES  
RECOVERED DURING THE IMPLEMENTATION OF ARTICLE 5  
BY THE UNITED KINGDOM**

## Demining Programme Office in the Falkland Islands – Exploitation 2015

## Demining Programme Office in the Falkland Islands – Technical Support 2013

## Demining Programme Office in the Falkland Islands – Technical Support 2010

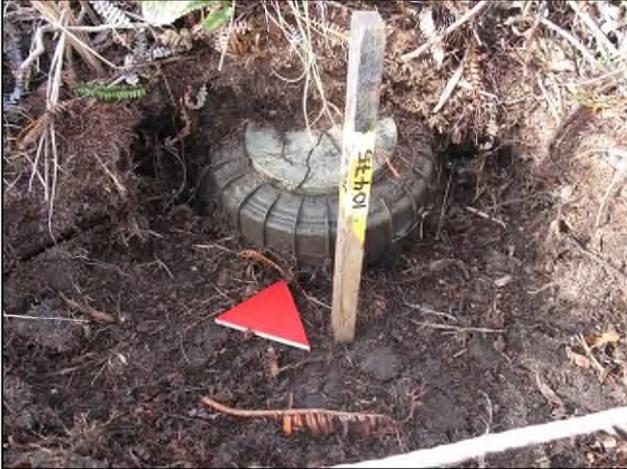
*SB-81 mines were located and partially exposed by deminers, then recovered by CK*

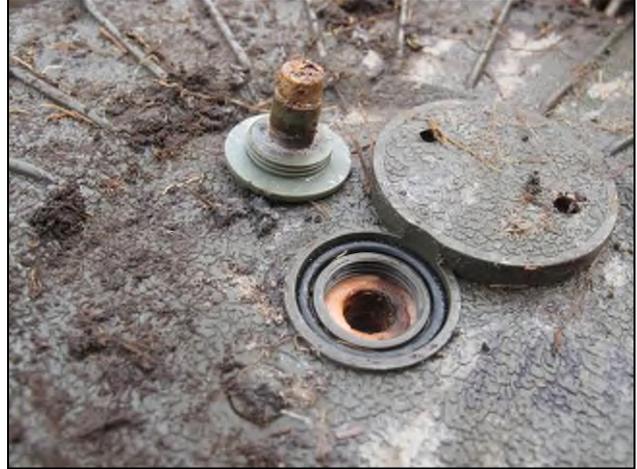
*AT mines were examined and then defuzed in the minefield. The condition of detonators was noted*

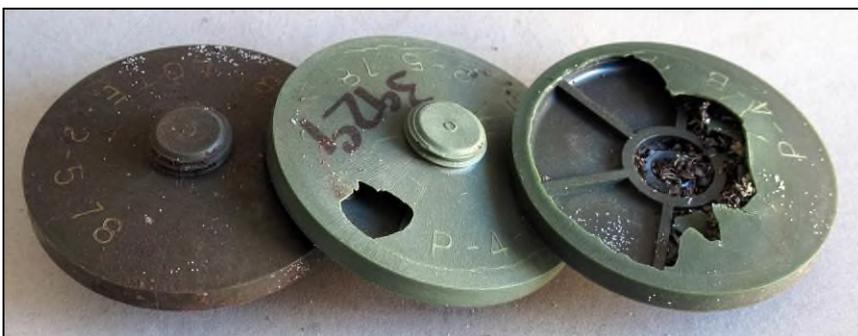
A significant proportion of the fuze casings had hardened and cracked, with many partially disintegrated. The proportion of degraded fuzes recovered so far during Phase 4A is substantially greater than on previous phases.

The primary result of casing degradation is the exposure of the inner fuze cavity, leading to the ingress of water. This tends to have two significant effects:

In examples where the top of the fuze casing had broken away, the striker spring and spacer were often missing altogether, leaving the mechanism incomplete. This means that the fuze could no longer function as designed.

*A range of degradation was present among P4B fuze casings*

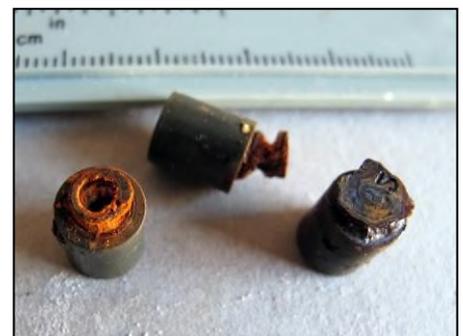
Any corrosion of the striker spring reduces its metallic mass and makes it even less detectable.

*Many springs were corroded*

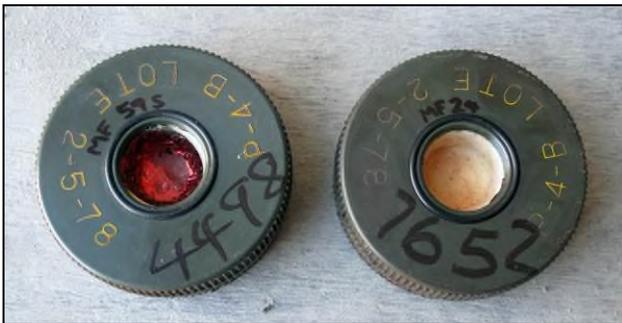
The foil is installed in the P4B body as a flat disc, but is broken when the fuze is fitted. In most cases, the foil ruptures in several places, creating 'fingers' that protrude into the fuze well. In some examples the foil remains virtually intact, while in others a portion is absent, but every P4B mine examined (including previous phases) has had some foil present.

Variations in the foil covering the main charge

- Trials are arranged to assess the feasibility of using GPR for the detection of the P4B.
- No attempt should be made to defuze SB-33 mines in the field.
- SB-33 mines should be recovered, fully fuzed, and demolished within the minefield. A special demolition procedure should be developed to ensure complete destruction.
- Scientific analysis should be conducted to investigate the changes occurring within the mine detonators, including the causes.
- The effects of ageing on recovered mines and other significant ordnance<sup>4</sup> continue to be monitored in future phases.
- Further data are needed on the location and circumstances of recovered mines in order to understand the factors affecting their condition. All contractors and authorities involved in demining operations should consider ways to collect such data without impeding clearance work.

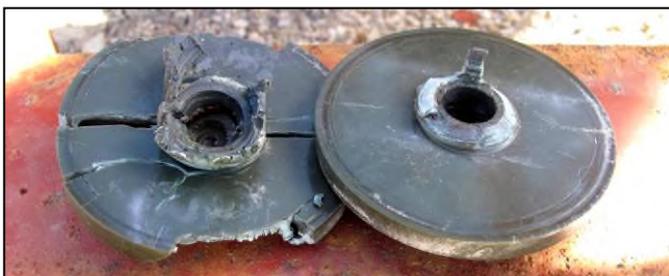
Out of those that exploded, the majority produced a weak effect that would probably fail to propagate to the main charge. In other words, actuation of mines in this category would be unlikely to cause injury.

Results from P4B detonator testing. The fuze on the left was one of the few that detonated fully; the one on the right barely had the energy to break the housing and would not have detonated the main charge

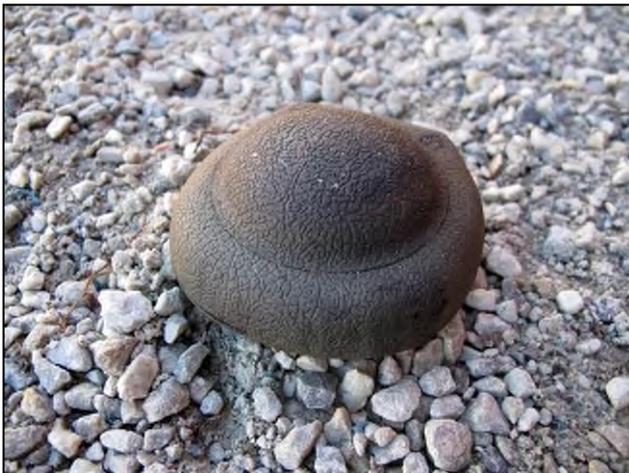
As noted in previous phases, the rubber covers of the SB-33 mines were generally domed where prolonged exposure to water had caused the material to swell. Despite the rubber remaining intact, it appears that water eventually permeated, since most mines were moist inside.

*The rubber domes on the SB-33 mines have swelled and allowed some moisture to enter*

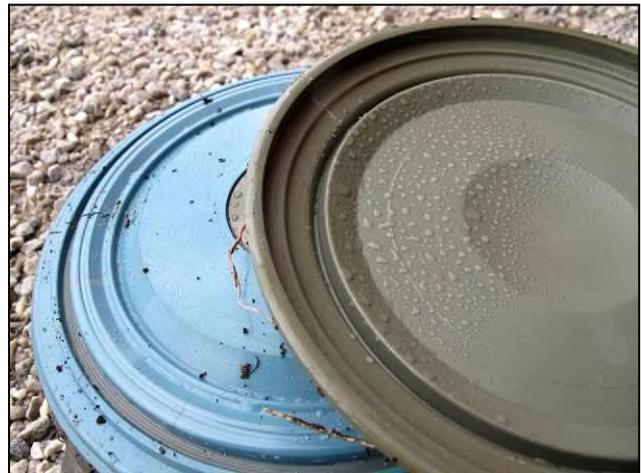
Moisture was also present in most of the SB-81 mines, despite the integrity of the rubber pressure plate. The SB-81 fuze is actuated pneumatically, so the seal and flexibility of this plate are critical to its function; both aspects appeared to be unaffected in the mines examined<sup>3</sup>

*The pressure plates (right) of the SB-81 mines were in good condition; most were wet on the inside*

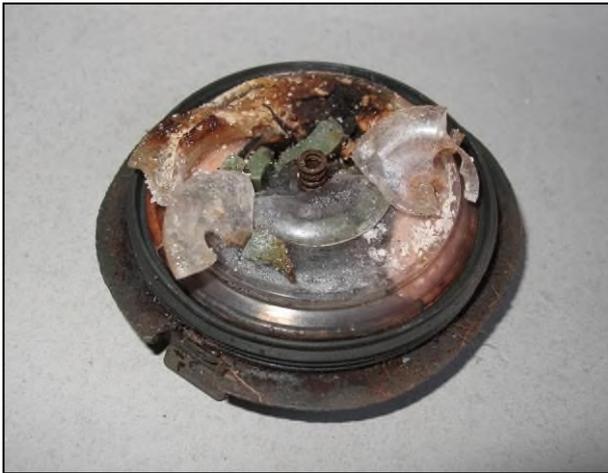
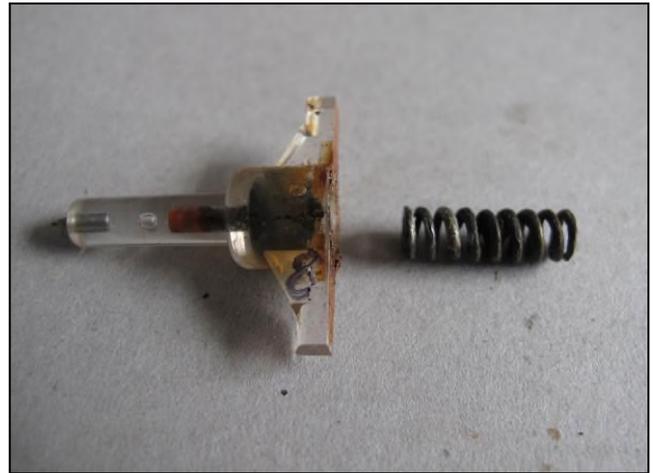
Even where water had entered the mines, rusting of the striker springs was generally light and superficial. This means that the metal content of both mine types still remains well above the detection threshold.

*Even when rusted, the steel springs had lost little of their original mass (SB-33 left, SB-81 right)*

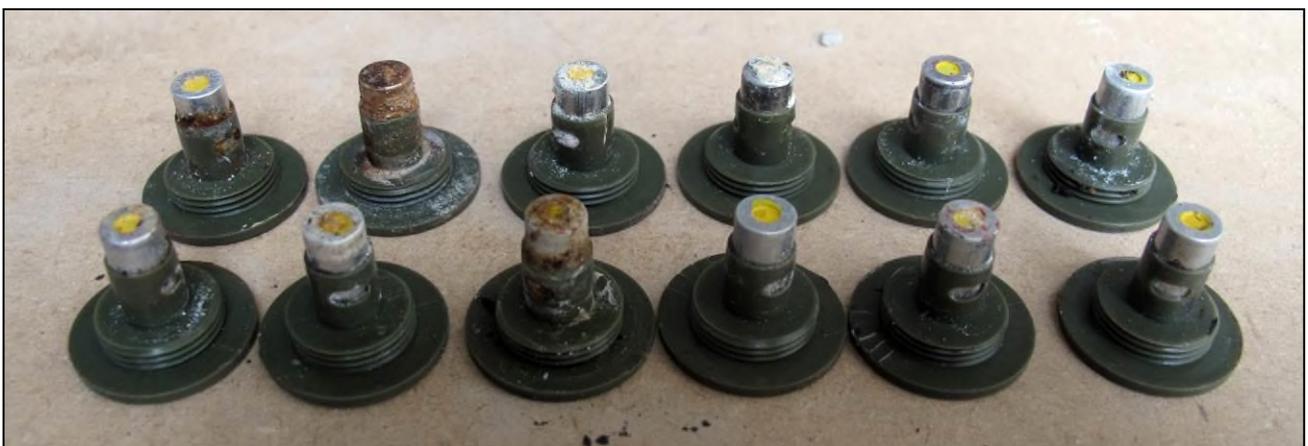
Most detonators appeared to be in good condition; however, some had white crusting (probably aluminium oxide from the detonator capsule) while others had a brown gelatinous exudation from the stab receptor.

*Detonators from the SB-81 mines, some of which show signs of deterioration*

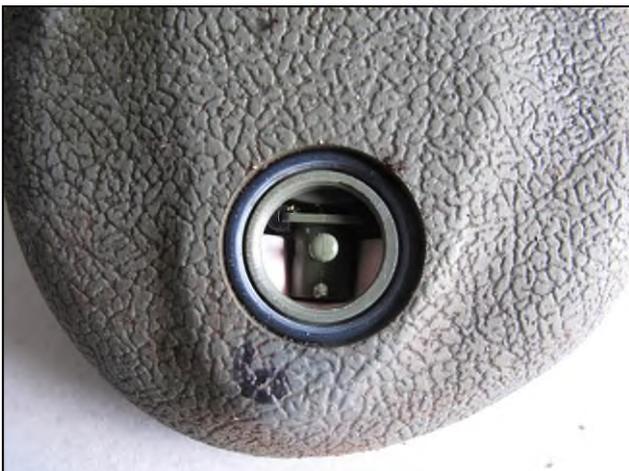
The gradual decline of detonators within SB-33 mines was also apparent from mines that had failed to fully function when actuated. Of the 16 mines examined, 6 had the firing pin embedded in the detonator, which did not initiate.

The presence of the firing pin in the stab receptor of the detonator is a major and unexpected hazard, since further movement could cause initiation. During disarming, the detonator is withdrawn from the mine body at right angles to the firing pin, meaning that the two components scrape together. If the detonator is still active, this could initiate the mine in the hands of the deminer.

*An SB-33 detonator plug removed to reveal the detonator still in position, impaled on the firing pin*

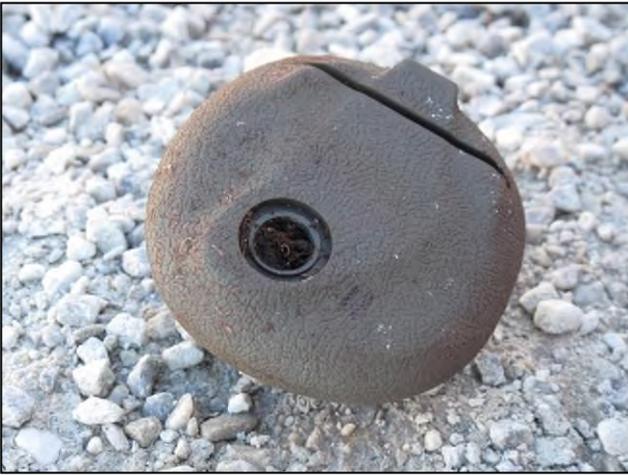
Several SB-33 mines had detonator plugs missing and were initially assumed to be unarmed

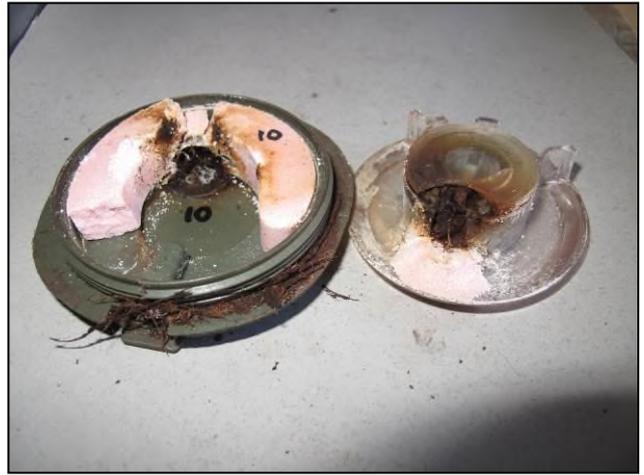
In each case, the detonator had exploded (ejecting the plug) but with insufficient force to initiate the main charge. The most likely explanation for this is deterioration of the detonators.

Examination revealed that the detonators had exploded, but failed to initiate the main charges

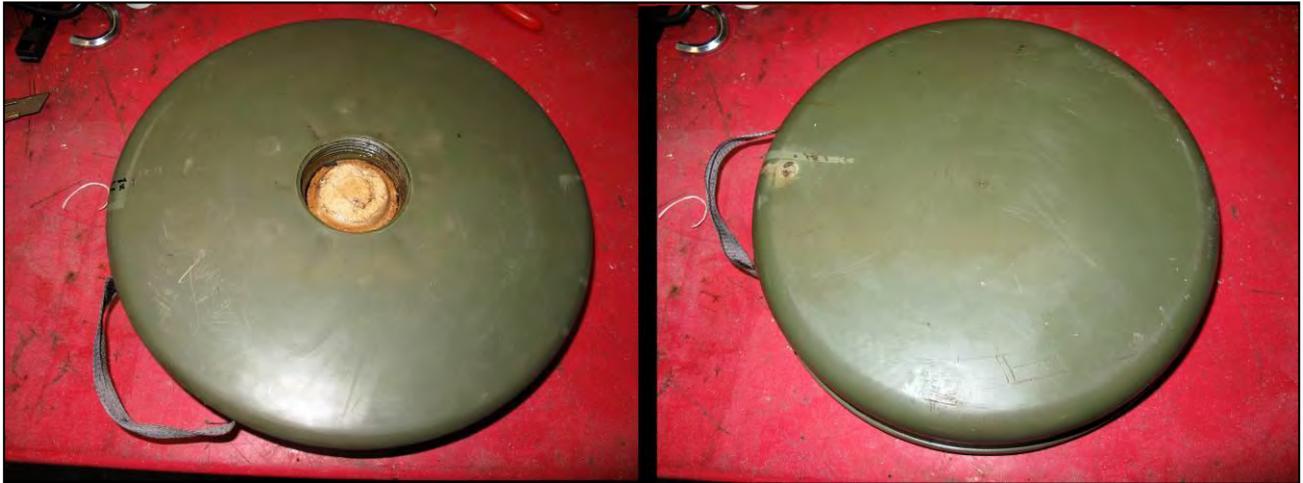
**Figure A5**

*The top surface (left) and underside (right) of the mine body with fuze removed. All of the mines recovered appeared to be in good condition superficially; however, every mine had cracks in the casing*

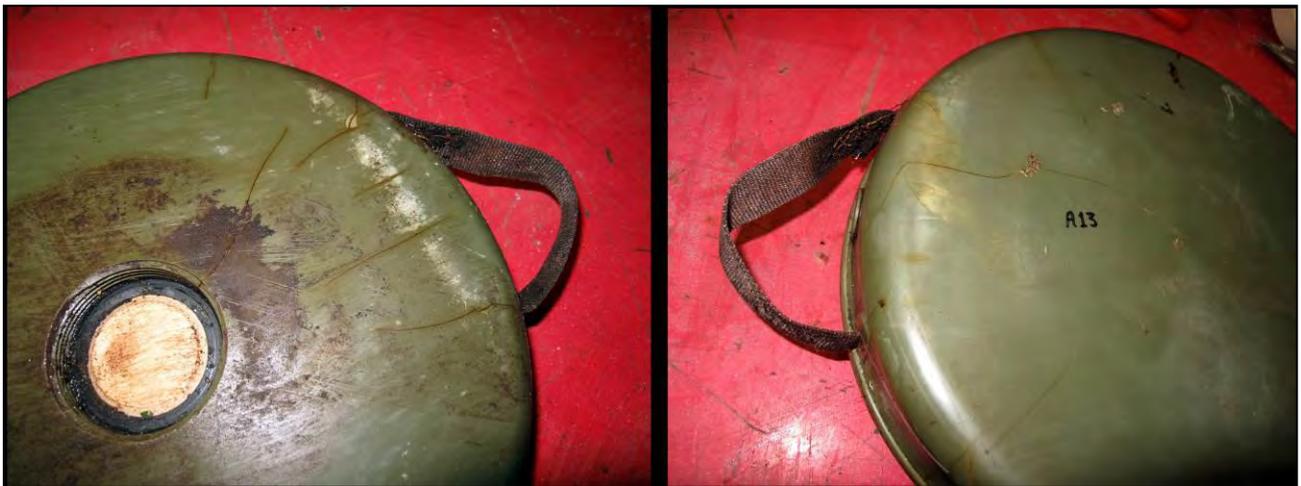
**Figure A6**

*Fine cracks in the casing allow the ingress of water; freezing then gradually extends the breaks*

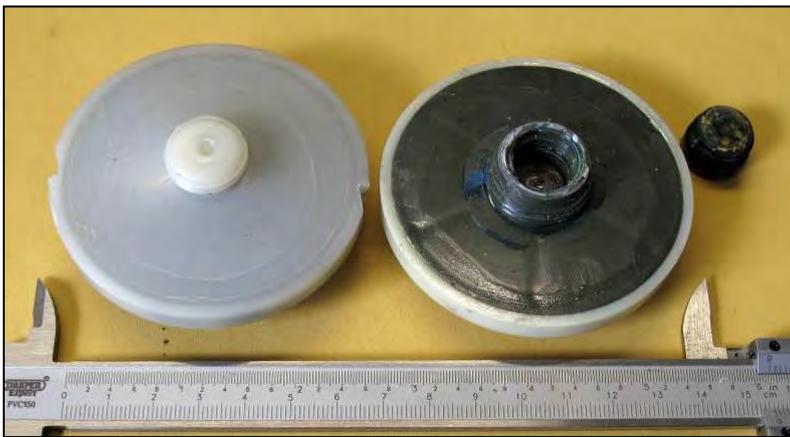
**Figure A9**  
The sealed fuze assembly is very similar to that used in the P4B anti-personnel mine. Water was found inside almost all of these units

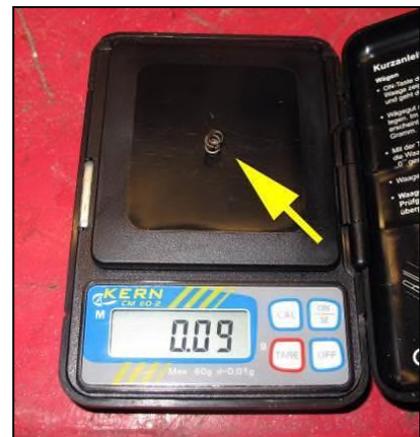
**Figure A10**  
Due to corrosion, this striker Spring weighed only 0.09 g

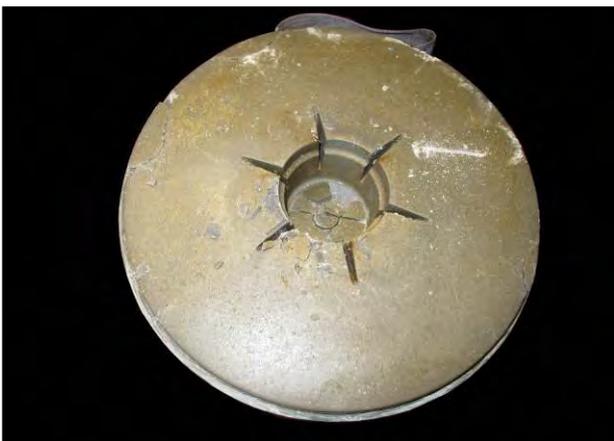
**Figure A11**  
Upper section of the casing removed to reveal the main charge; most were in good condition with little or no cracking or deterioration evident in the explosive. Although the inside of the plastic casing was wet, the cast filling contains very few voids

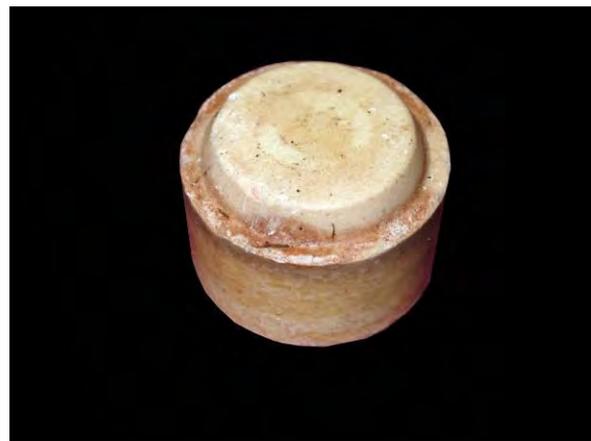
**Figure A12**  
Booster pellets are composed of a pressed TNT/RDX (60/40) mixture and virtually all were in good condition. Despite the neoprene seal between the base of the fuze and the booster, all of the booster pockets contained water

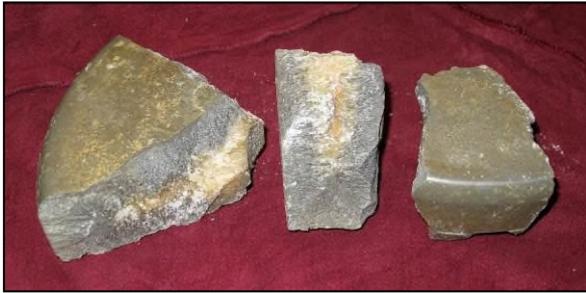
**Figure A13**

*The composition of the main charge is quoted as being TNT/RDX/aluminium (50/30/20) but, as shown here, the mixture is rarely homogenous. The aluminium content does not affect the detectability of the mine*

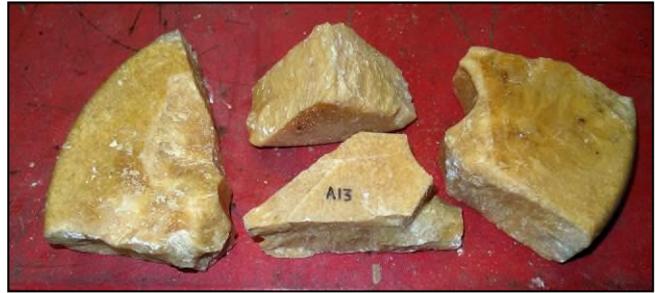
**Figure A14**

*The proportions of the constituents in the high explosive varied significantly; this sample contained no aluminium whatsoever. This is evidence that different material characteristics and specifications may be found within the same lot number*

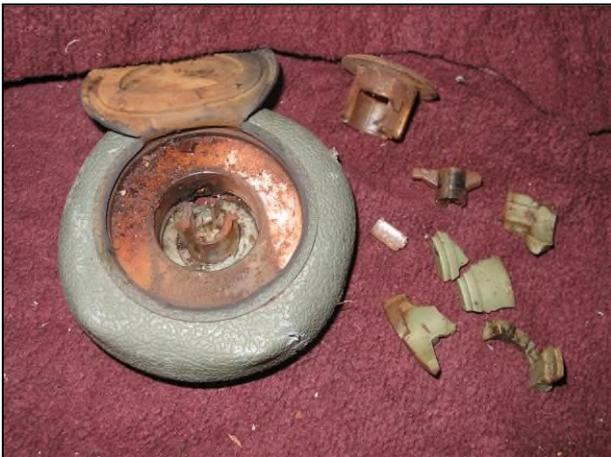
**Figure B6**

*Removal of the fuze components exposed the full extent of the damage*

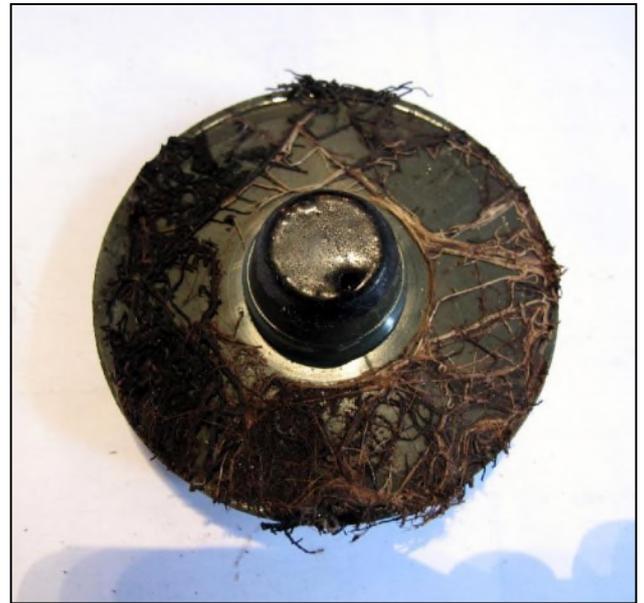
Figure 2

Many had some degree of root penetration between the underside of the fuze (Figure 2) and the mine body. This type of growth would not affect performance, although it is possible that further enlargement of the roots might eventually force the two assemblies apart, resulting in malfunction.

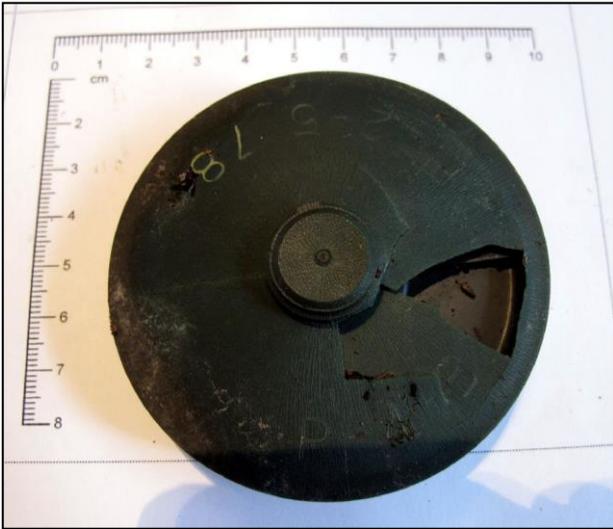
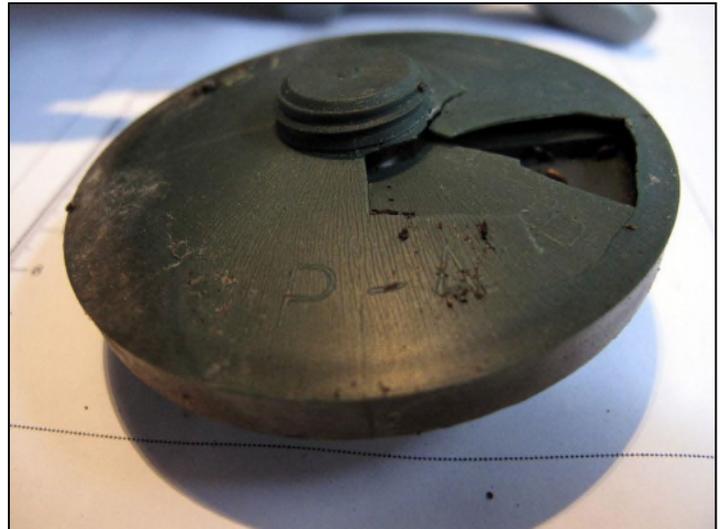
The P4B pressure plate shown in Figures 4 and 5 shows the type of long-term deterioration expected in ABS plastic. Increasing brittleness has caused fine cracks where the plastic is under stress; this has led to eventual failure, permitting the ingress of water. In most samples examined, cracking was not immediately visible; however, it is evident that the plastic is becoming more brittle and that all casings would eventually reach this stage. Previous studies have shown that such deterioration accelerates, since the effects (such as increasing the exposed surface area) make the material even more vulnerable to further degradation. Extensive tests would be required in order to assess the rate of degradation.

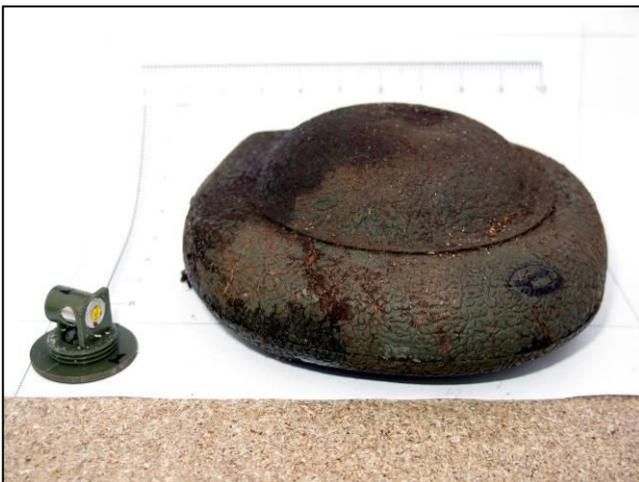
Seventeen SB-33 mines were recovered from a mixture of dry and wet sites (Figures 1 and 2). None of the SB-33 mines examined showed signs of significant external degradation, other than a notable increase in the profile of the rubber pressure plate; this is clear from Figures 3 and 4.

**Figure 3:** An SB-33 recovered from the Falklands; note the domed profile of the pressure plate

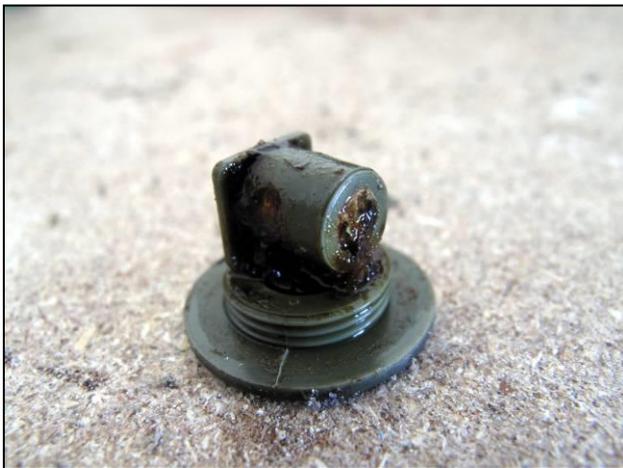
**Figure 10:** Some detonator capsules did show significant signs of degradation

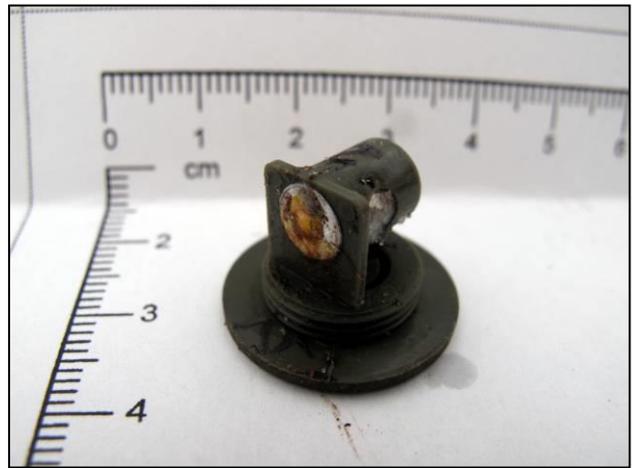
**Figure 11:** The yellow seal on the stab receptor appears to have been breached

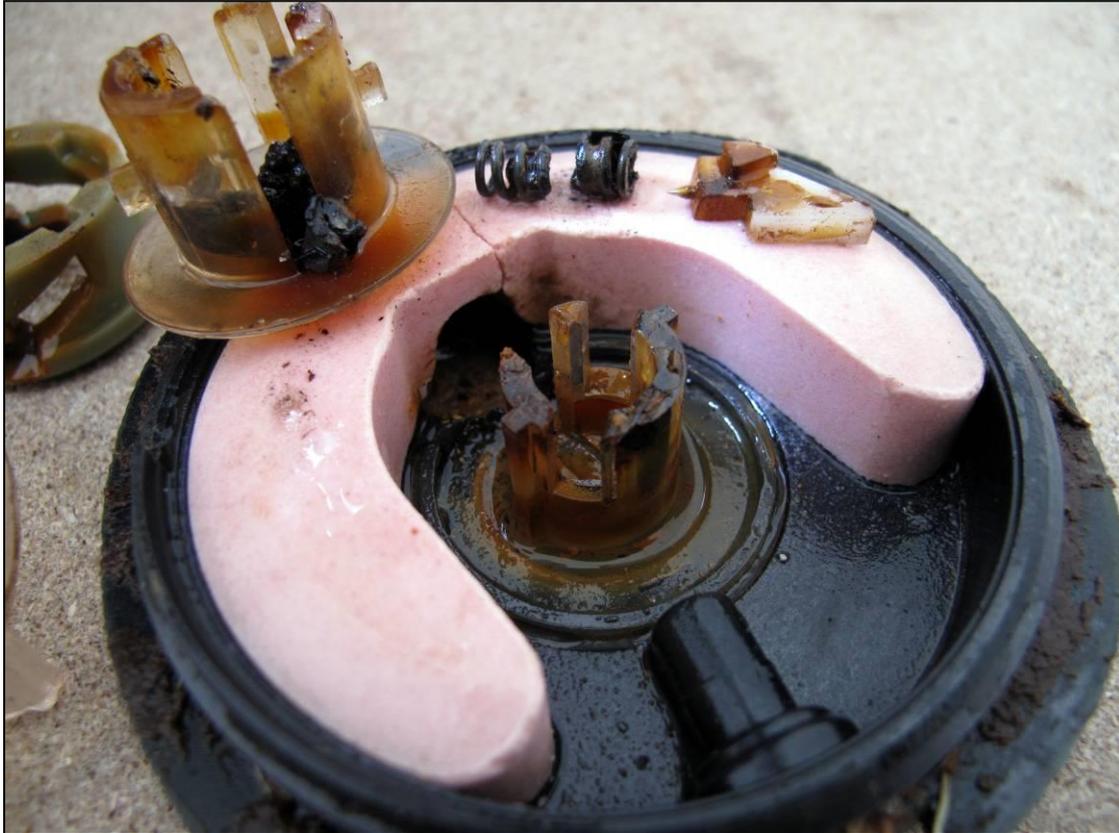
**Figure 12:** Inside an SB-33 which had been penetrated by water. The most likely cause of failure would be the disintegration of the striker spring, although degradation of the detonator capsule might also prevent the mine from operating. Note that the stainless steel firing pin is virtually unaffected

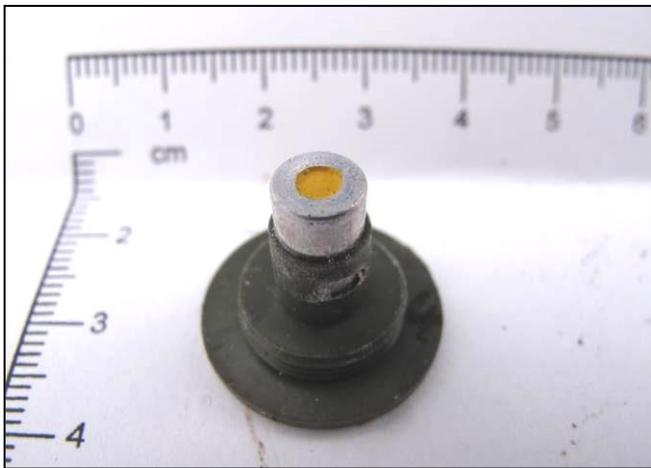
**Figure 10:** Some detonator capsules showed significant signs of degradation

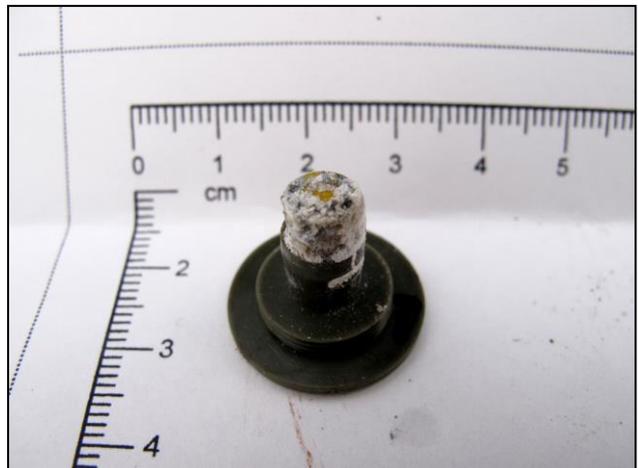
**Figure 11:** The yellow seal on the stab receptor appears to have been breached
