**INFORMATION ON THE EXPLOITATION OF MINES  
RECOVERED DURING THE IMPLEMENTATION OF ARTICLE 5  
BY THE UNITED KINGDOM**

## Demining Programme Office in the Falkland Islands – Exploitation 2015

## Demining Programme Office in the Falkland Islands – Technical Support 2013

## Demining Programme Office in the Falkland Islands – Technical Support 2010

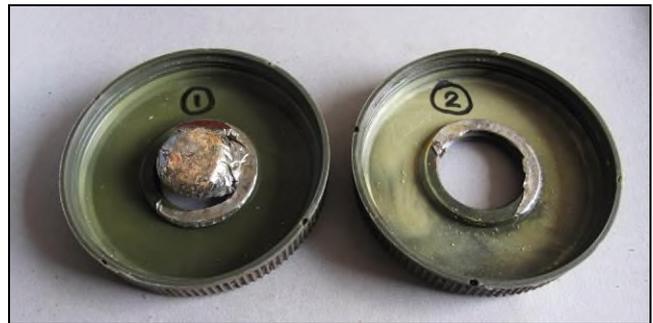
The foil is installed in the P4B body as a flat disc, but is broken when the fuze is fitted. In most cases, the foil ruptures in several places, creating 'fingers' that protrude into the fuze well. In some examples the foil remains virtually intact, while in others a portion is absent, but every P4B mine examined (including previous phases) has had some foil present.

View of the foils from the inside of the casing

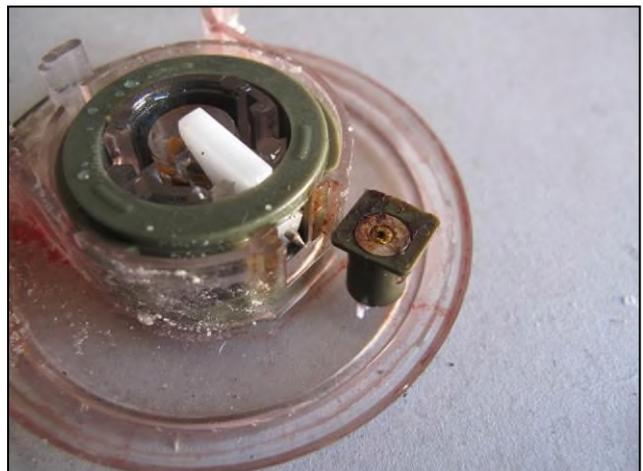
*An SB-33 disassembled, showing the pin in the fired position and a hole visible in the detonator*

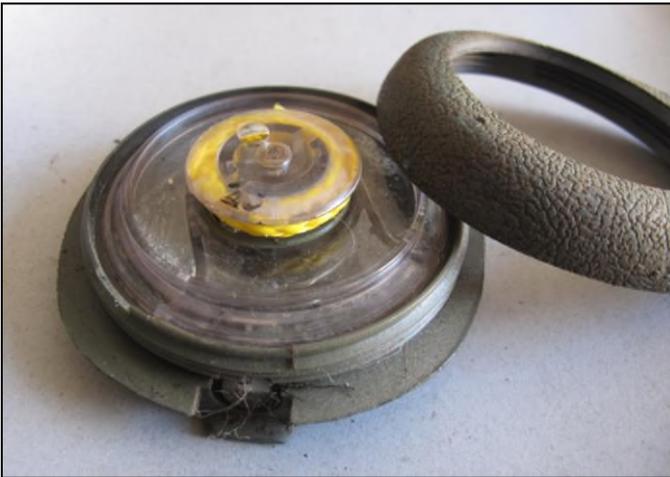
*It is often possible to establish whether or not an SB-33 has been actuated by carefully feeling the position of the central plunger (through the rubber cover)*

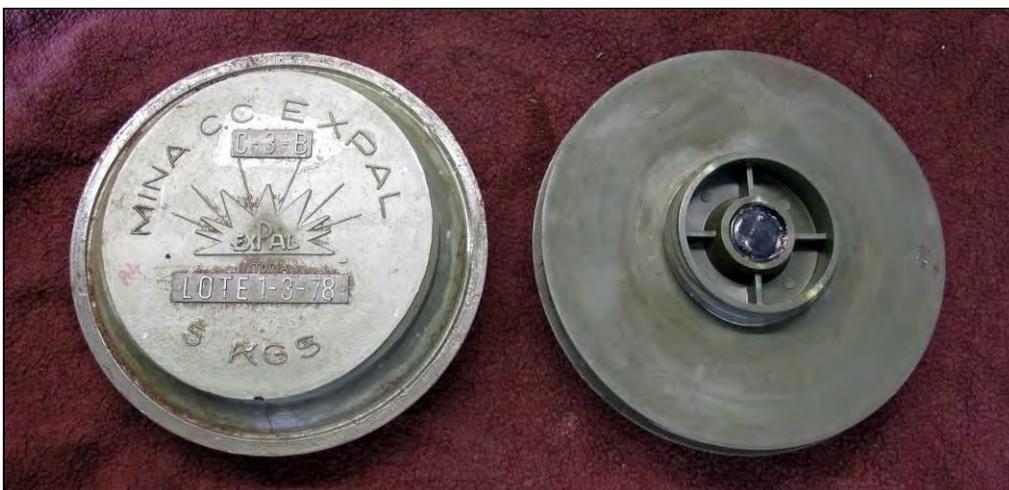
**Figure A7**

*The top surface (left) and underside (right) of the fuze assembly. Most of the fuze bodies appeared to be undamaged and well sealed, yet almost all were wet inside*

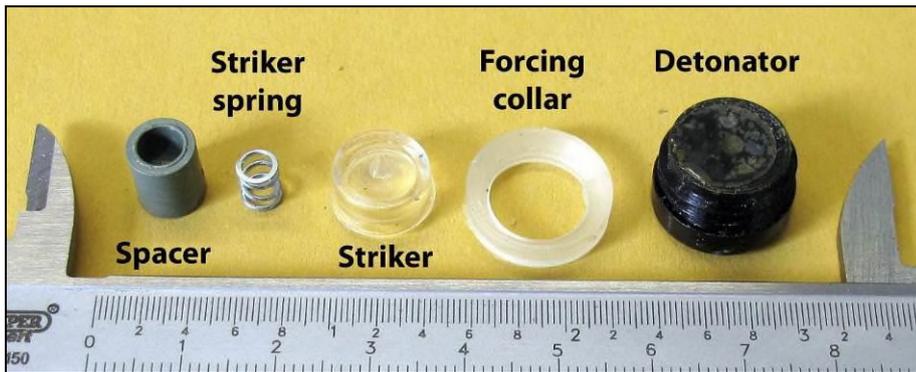
**Figure A8**  
Components of the C3B fuze mechanism. Pressure applied to the top of the fuze forces the striker through a flexible 'forcing collar', which accelerates the striker into the detonator. The spring makes relatively little contribution to this effect

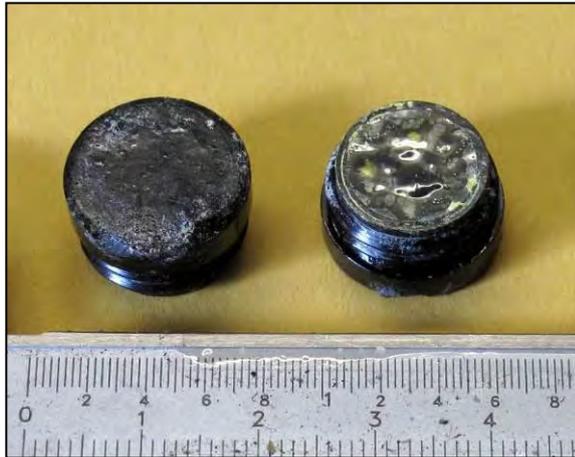
**Figure A15**

*All of the C3B detonator assemblies examined were wet. The protective layer of clear plastic film over the stab receptor (right) did not provide an effective water-tight seal*

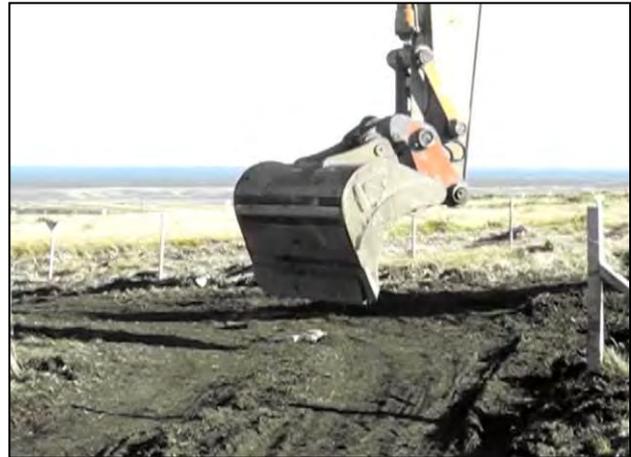
**Figure A16**

*Subjecting live fuzes to an operating load (>300 kg) using an excavator bucket did not produce any detonations. The most likely explanation is that the stab-receptive composition is no longer functional*

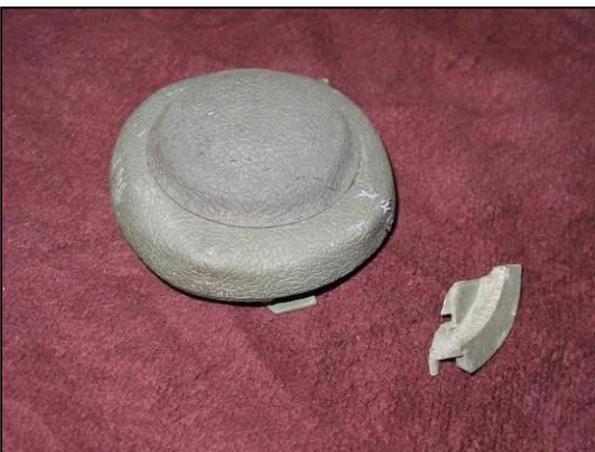
3. The isolated mine found in SA064 (**Figure B2**) showed obvious damage, particularly to the base (**Figure B3**) where the detonator plug was cracked and a section of the mine casing had been broken away. The broken section of the base was found close to the mine body.

**Figure B2**  
The SB-33 mine found in SA064

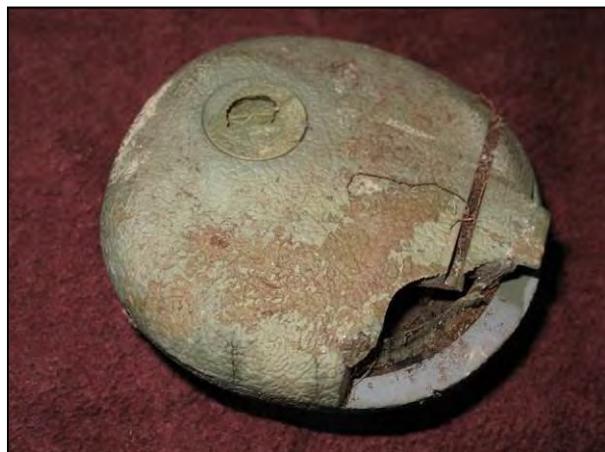
**Figure B3**  
Base view of the casing

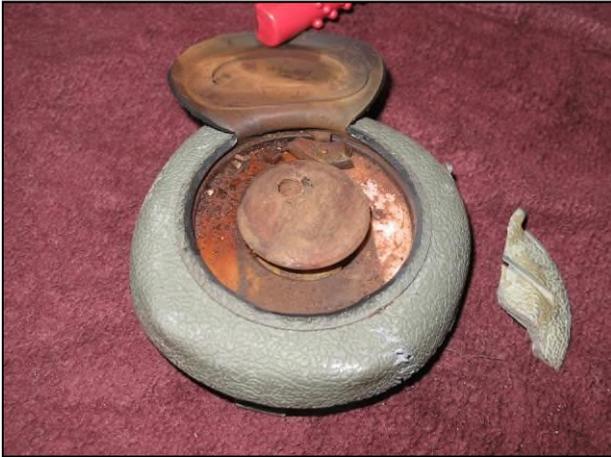
**Figure B4**

*On initial inspection, the fuze and main charge appeared to be relatively intact. The ingress of water would not prevent the mine from functioning*

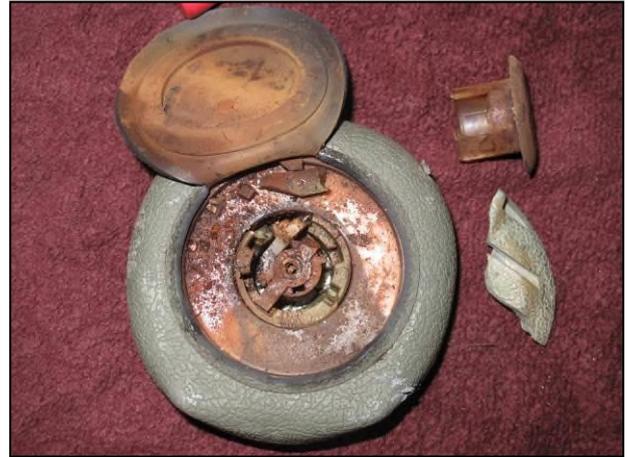
**Figure B5**

*Removal of the fuze plunger revealed that the several of the fuze components had been shattered and the striker displaced*

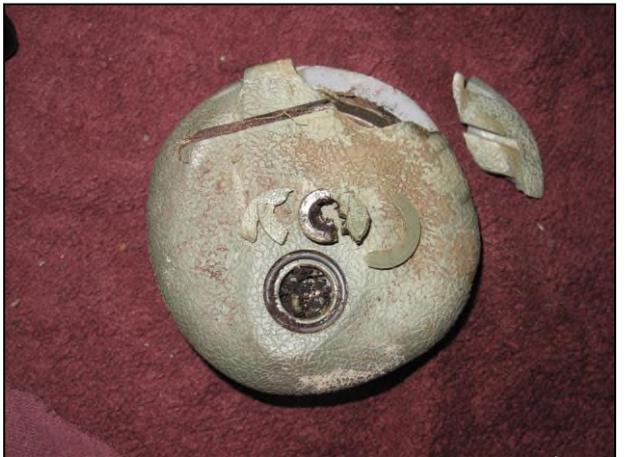
**Figure B7**

*The detonator plug had also been shattered and could not be used to remove the detonator*

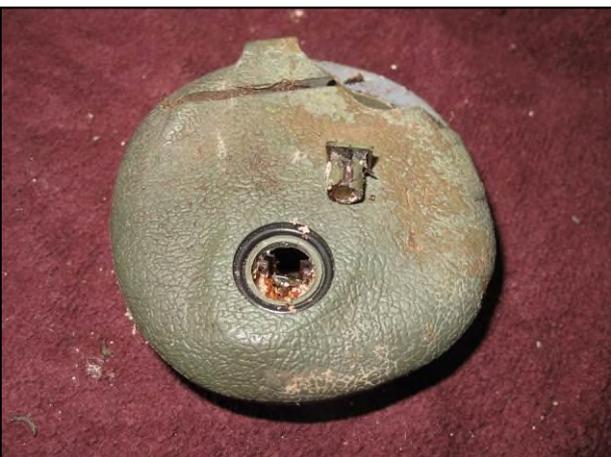
**Figure B8**

*The detonator was seized into place and surrounded by impacted explosive from the main charge*

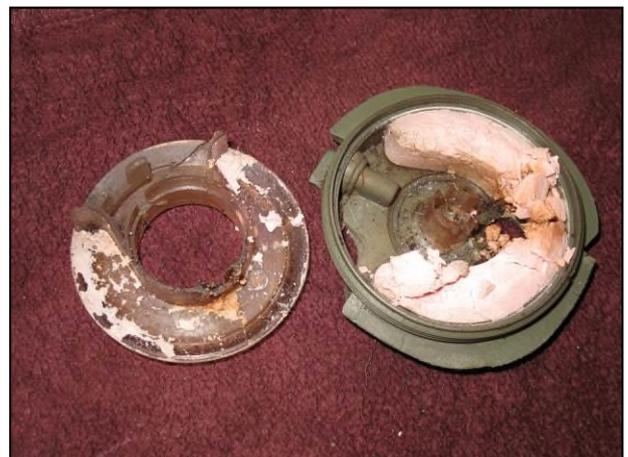
**Figure B9**

*The main charge, normally a rigid horseshoe of pressed explosive, had been pulverised*

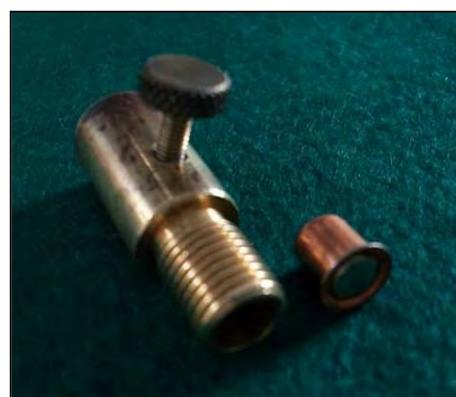
**Figure C2**

*The fuze holder with percussion cap removed. The cap unit is a standard 12 bore shotgun primer. Although robust, these are unlikely to remain functional after 30 years exposure to wet conditions*

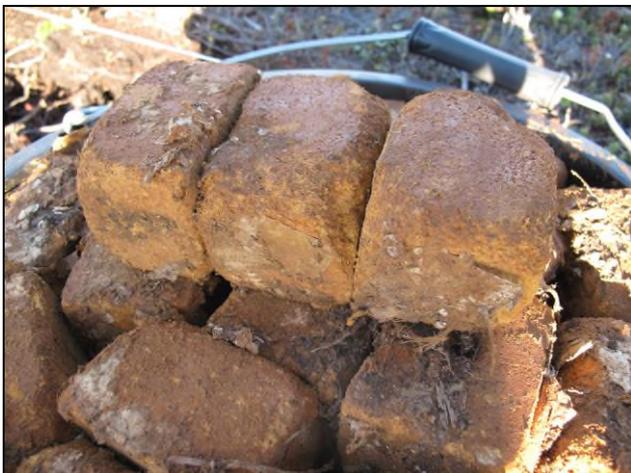
**Figure C4**  
*TNT charges from a booby trap in SA064. These appear to have been 400 g blocks of pressed TNT, wrapped in waxed paper. Pressed TNT is deemed ‘cap sensitive’, meaning that it can be initiated directly by a No 8 strength detonator. The edges of the blocks have been eroded but the bulk of the explosive remains intact. Historical data on TNT suggests that it can remain capable of detonation for several decades*

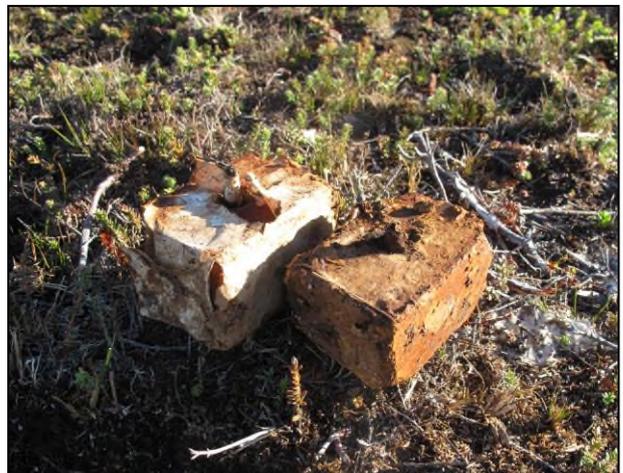
**Figure C5**  
*TNT blocks containing detonators and the remnants of safety fuzes. It is clear that any pyrotechnic composition in the fuse or detonator will be non-functional. However, findings from the Ageing Study (involving explosives of a similar type and age) suggested that the primary explosive in the detonator may be viable; this means that the explosive could be initiated by either fire or substantial impact*

5. The booby traps found during Phase 3 were incapable of functioning as designed for the following reasons:
  - a. Firing devices were absent;
  - b. Even if firing devices had been present, data from the Ageing Study suggests that internal components (such as the steel striker spring) would be seized and incapable of functioning;

- c. The shotgun primer used as the percussion cap is unlikely to remain functional after prolonged exposure to wet conditions;
  - d. The pyrotechnic compositions of the safety fuse and detonator flash receptor are vulnerable to water and were virtually unprotected for more than 30 years.

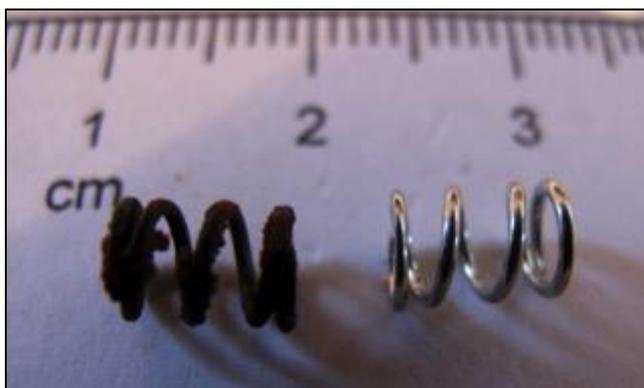
**Figure 4**

*Corrosion testing.*

*Two springs of the type used in the Spanish P4B and C3B mines. The spring on the left has been immersed in weak saline solution for two weeks. The effect indicates that the spring is vulnerable to rusting, which might reduce its detectability*

14. The conclusion of the corrosion test was that springs were likely to be heavily rusted if water had penetrated the fuze assembly. If so, the detection signature might be even lower, making the mine virtually undetectable<sup>4</sup>.

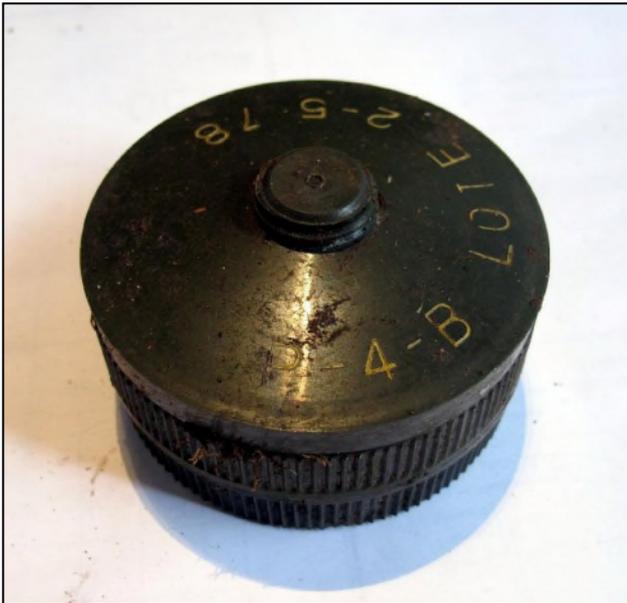
Figure 1

Most of the P4B mines examined showed little obvious sign of external degradation, with both the colour and the texture of the plastic casing appearing virtually 'as new' (Figure 1). However, the condition of some mines suggests that this initial visual impression may be misleading, and that all of the plastic casings are now beginning to deteriorate.

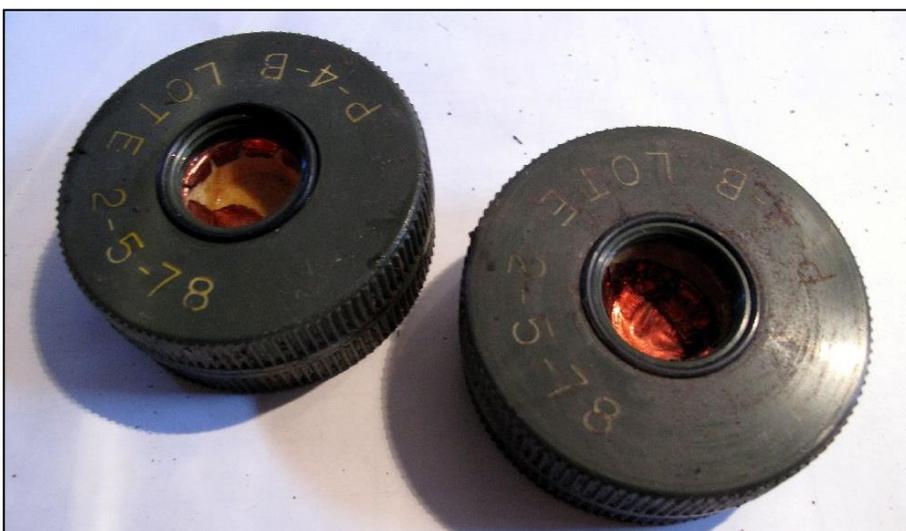
Figure 3

Throughout the course of the clearance operation, all but one of the P4B mines examined had the red lacquered lead foil present in fuze well. As the fuze assembly is fitted, this foil ruptures in unpredictable patterns (Figure 3). The shape of the ruptured foil is known to affect the return on short-wave radar and may also affect the signature with some metal detectors.

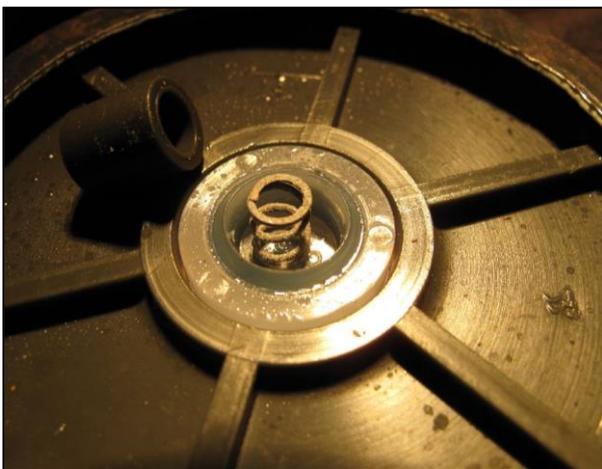
**Figure 6**

Even where water had penetrated the fuze assembly, the firing spring (Figure 6) was in remarkably good condition and remained fully functional. This was surprising, although, had the mines been nearer the coast, salt-water would probably have caused more extensive rusting. This would further degrade the detection signal from the small metallic mass.

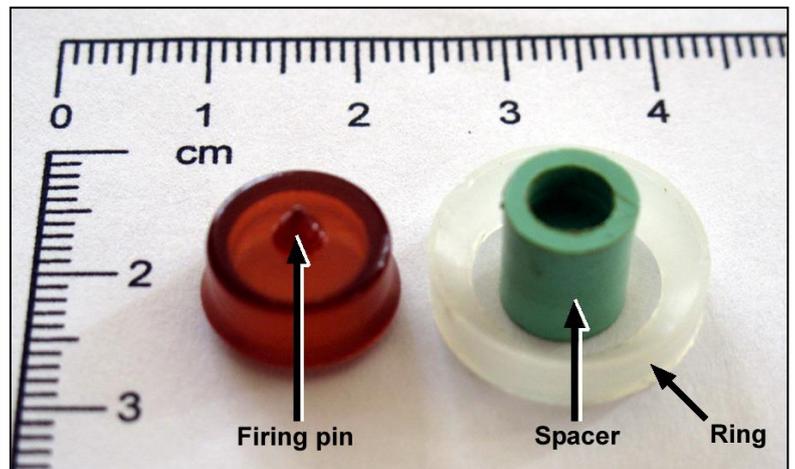
**Figure 7**

It is important to note that the P4B can function regardless of the spring's condition. The firing pin is made from polymethylacrylate plastic, which is unlikely to deteriorate significantly within the foreseeable future. It is forced through a polythene ring by a spacer and this action alone may be sufficient to cause initiation without the additional impetus of the spring. These plastic components are shown in Figure 7.

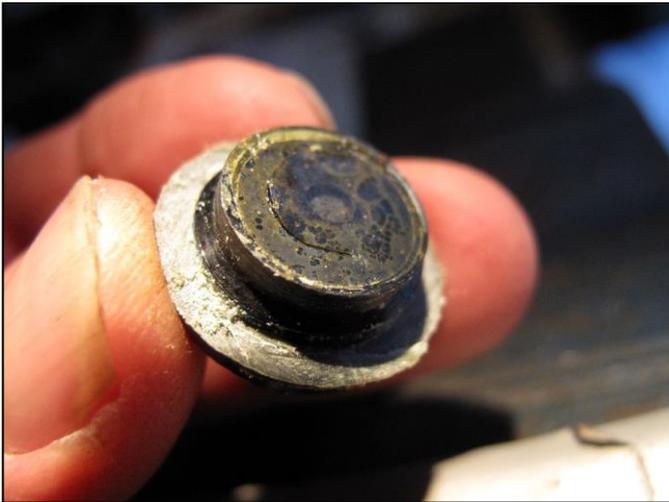
**Figure 8**

The detonator assembly is bonded into the fuze body and has to be cut from the mine, as shown in Figure 8. The stab-sensitive receptor in the centre is covered by a thin plastic film (seen here having been cut using a scalpel) to keep it dry. A similar assembly, shown in Figure 9, was full of water.

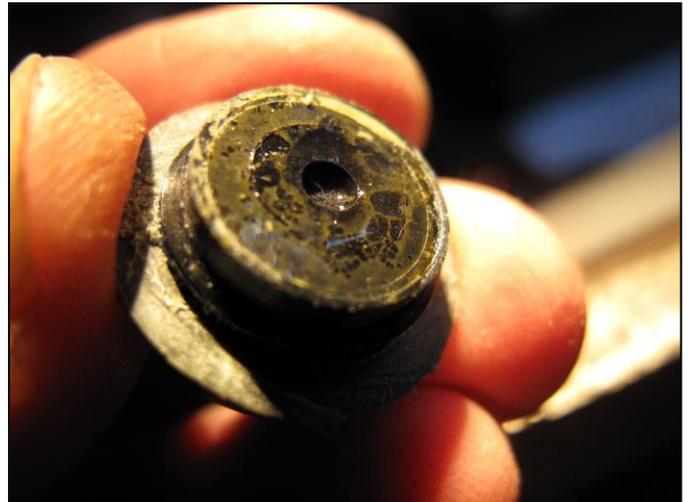
**Figure 9**

The presence of water might prevent the stab receptor from initiating, since water-soluble compounds are used within the composition. This is likely to be the primary cause of failure for P4B mines in the near term.

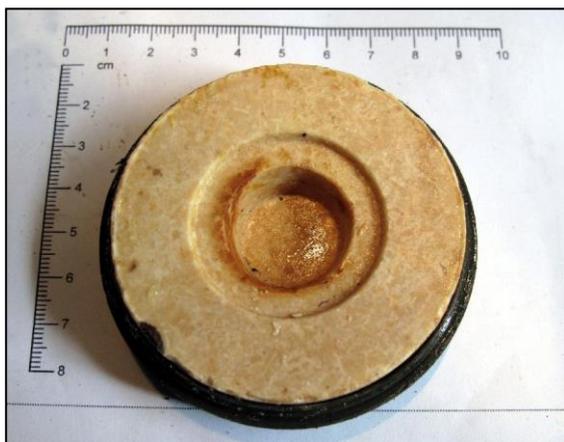
**Figure 10**

As expected, the pressed TNT charges (Figure 10) were in good condition, despite many being wet. TNT is relatively stable, especially when protected from sunlight. This High Explosive (HE) content is likely to remain functional for the foreseeable future.

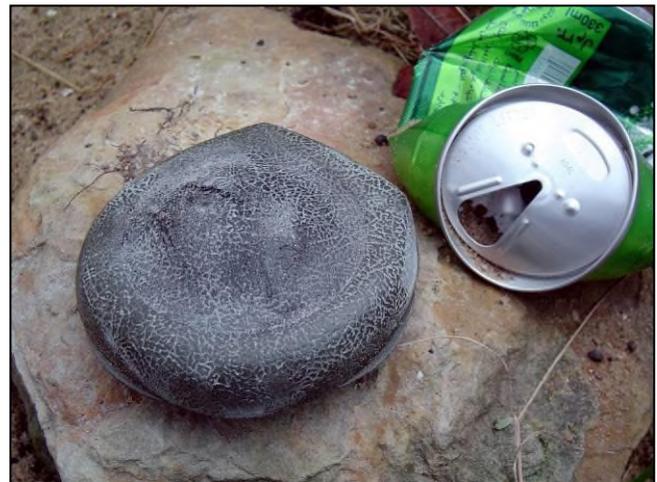
**Figure 4:** The normal appearance of the SB-33, with a relatively flat pressure plate

Expansion of the rubber appears to be due to the material softening when wet, although it continued to be waterproof. As the rubber dried, the height of the dome reduced noticeably, but not to the original profile.

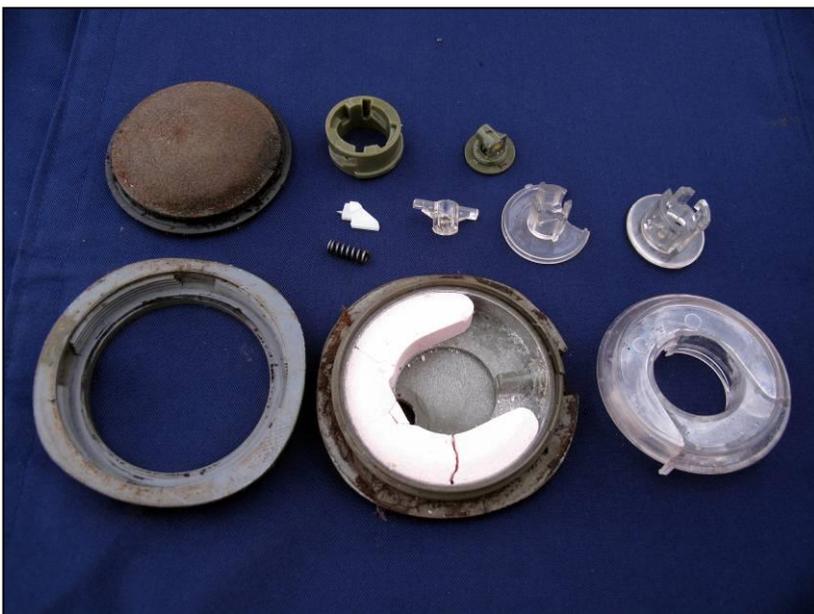
**Figure 7**

Figure 7 shows a recovered SB-33 disassembled. Most of the clear plastic internal fuze components are made from polycarbonate, and are therefore extremely strong.

None of the internal components showed any mechanical damage. The main charge ( RDX/HMX ) was often cracked, but this would not affect performance.

Although the mines were generally well sealed, several were damp inside. In many cases this had caused very minor rusting of the striker spring (which is made from spring steel 'piano wire'). This superficial corrosion would have no effect on the performance of the mechanism, nor would it effect the detectability of the mine.

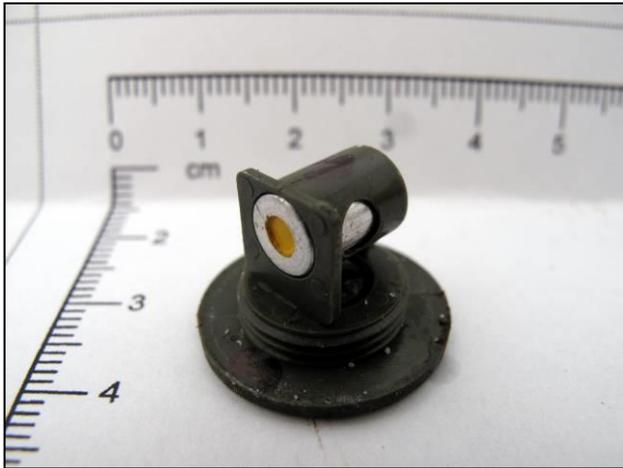
**Figure 8:** Most detonator assemblies were in very good condition

Most of the aluminium detonator capsules were in good, functional condition (Figures 8 and 9), but some did show significant signs of corrosion; see Figures 10 and 11.

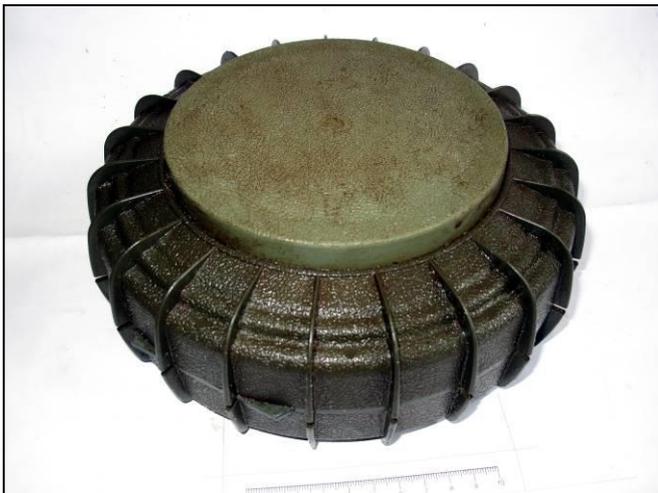
**Figure 3:** An SB-81 recovered from the Falklands

Fifteen SB-81 Anti-Tank (AT) mines were recovered from a mixture of dry and wet sites (Figures 1 and 2). None of these mines showed signs of significant external degradation; in fact, their appearance was virtually 'as new', as shown in Figures 3 and 4.

The casing of the SB-81 is made from polycarbonate and showed no indication of deterioration whatsoever. Even the pressure plate, which is made from a polyester elastomer, appeared to be in pristine condition.

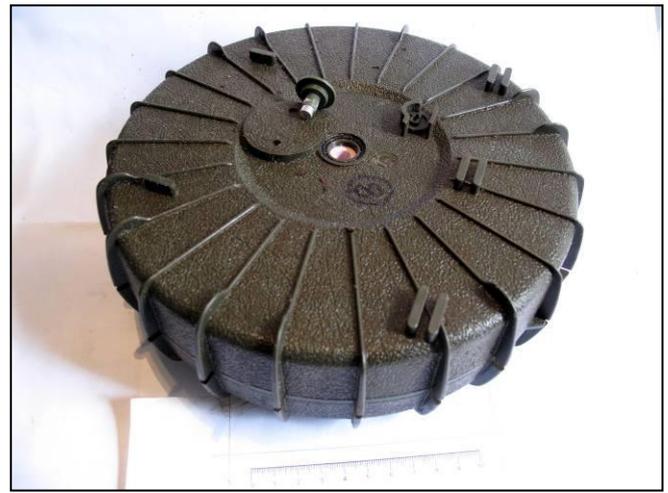
**Figure 4:** Base view of the SB-81

Examination of the casing and pressure plate showed that all of the mines had remained watertight. Where there was evidence of moisture on the inside, as with the SB-33, this appeared to be because the detonator plug (shown in Figure 4) had not been tightened sufficiently.

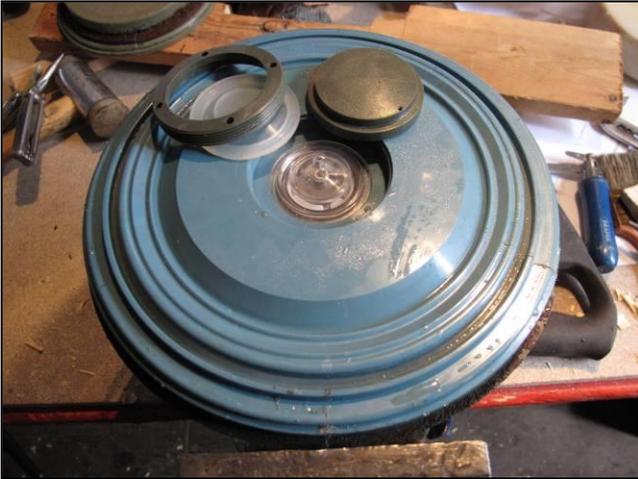
**Figure 5**

With the halves of the casing separated, the internal components could be examined. Figure 5 shows upper section of the mine with the pressure plate removed to reveal the top of the fuze assembly. The seal around the edge of the pressure plate is critical to the pneumatic function of the fuze; this is a common point of failure among Italian AT mines. Although small roots were present on the outside (Figure 6) all seals were intact.

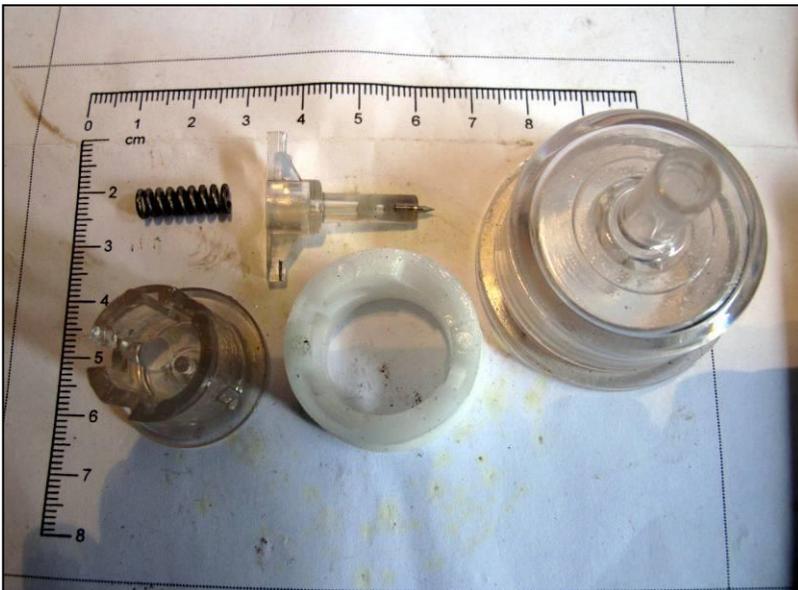
**Figure 7**

Figure 7 shows the major components of the fuze mechanism. The fuze is similar to that used in the SB-33, with most of the clear plastic internal fuze components made from polycarbonate.

As with the SB-33 mines, the SB-81s were generally well sealed, but several were damp inside. In many cases this had caused very minor rusting of the striker spring (which is made from spring steel 'piano wire'). This superficial corrosion would have no effect on the performance of the mechanism, nor would it effect the detectability of the mine. The firing pin is made from stainless steel and none of those examined showed any corrosion.

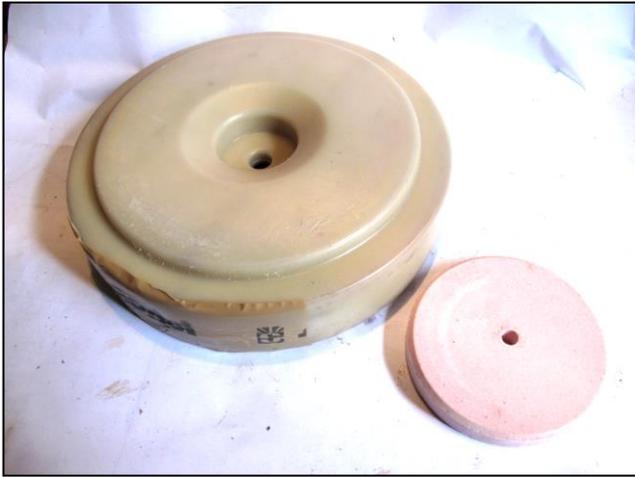
The main charge (approximately 2 kg of TNT/RDX/HMX) is encapsulated in plastic, while the booster (approximately 140 g of RDX/HMX/wax) is in the form of a pressed disc. These are shown in Figure 8. Removal of the plastic showed the main charge to be in perfect condition (Figure 9).

**Figure 8:** The main charge and booster

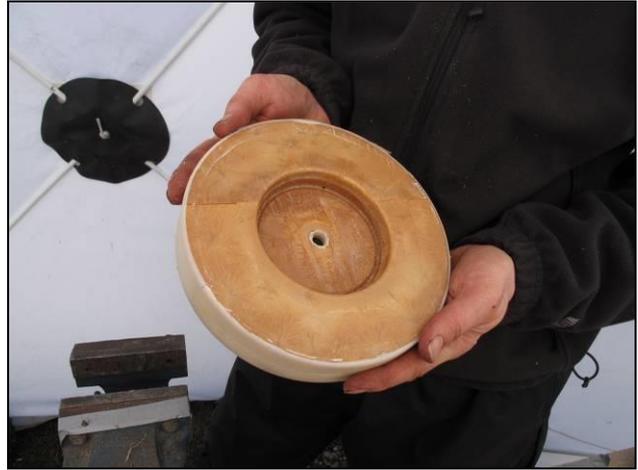
**Figure 9:** The main charge casting
